Office of Structural Materials

Quality Assurance and Source Inspection

Contract #: 04-0120F4Cty: SF/ALA Rte: 80 PM: 13.2/13.9File #: 1.28**WELDING INSPECTION REPORT****Resident Engineer:**Siegenthaler, Peter**Address:** 333 Burma Road**City:** Oakland, CA 94607**Report No:** WIR-025930**Date Inspected:** 12-Aug-2011**Project Name:** SAS Superstructure**OSM Arrival Time:** 700**Prime Contractor:** American Bridge/Fluor Enterprises, a JV**OSM Departure Time:** 1530**Contractor:** American Bridge/Fluor Enterprises, a JV**Location:** Jobsite**CWI Name:** John Pagliero**CWI Present:** Yes No**Inspected CWI report:** Yes No N/A**Rod Oven in Use:** Yes No N/A**Electrode to specification:** Yes No N/A**Weld Procedures Followed:** Yes No N/A**Qualified Welders:** Yes No N/A**Verified Joint Fit-up:** Yes No N/A**Approved Drawings:** Yes No N/A**Approved WPS:** Yes No N/A**Delayed / Cancelled:** Yes No N/A**Bridge No:** 34-0006**Component:** SAS OBG**Summary of Items Observed:**

## WELDING INSPECTION REPORT

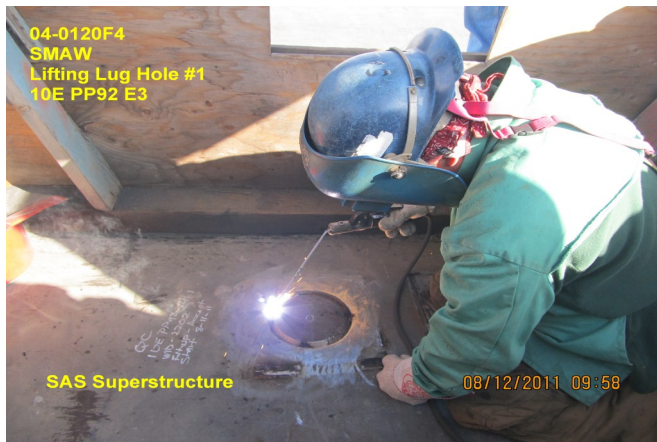
The QA inspector observed ABF welder Salvador Sandoval ID# 2202 performing Shielded Metal Arc Welding (SMAW) in the 1G flat position on Lifting Lug Hole (LLH) #1 located at 10E PP92 E3. The QA inspector verified the fit up of the joint and found it to be satisfactory. The QA inspector observed the QC inspector identified as Fred Von Hoff monitoring the progress to ensure the welding parameters were in compliance pertaining to ABF-WPS-D15-1050A-CU. The parameters were recorded as (Amperes=132). The QA inspector made subsequent observations throughout the shift to monitor quality and upon completion of the work the QA inspector observed QC perform a Visual Inspection (VT) on the weld and found no indications which the QA inspector verified and found the work to be visually acceptable.

The QA inspector noted that the work appeared to be in general conformance with the contract documents.
